NATIONAL REGISTER OF HISTORIC PLACES INVENTORY -- NOMINATION FORM

Westminster Congregational Church, 3600 Walnut Street, is located on the southwest corner of Thirty-sixth and Walnut streets in Kansas City's Westport District. The church has a frontage of approximately 109 feet on East Thirty-sixth Street and 91 feet on Walnut Street. The structure consists of the church proper, and an addition housing administrative offices, Sunday School rooms and a room for social activities. The church is asymmetrical in plan, with its main entrance on the north facade. The Sunday School addition is rectangular in plan.

WESTMINSTER CONGREGATIONAL CHURCH

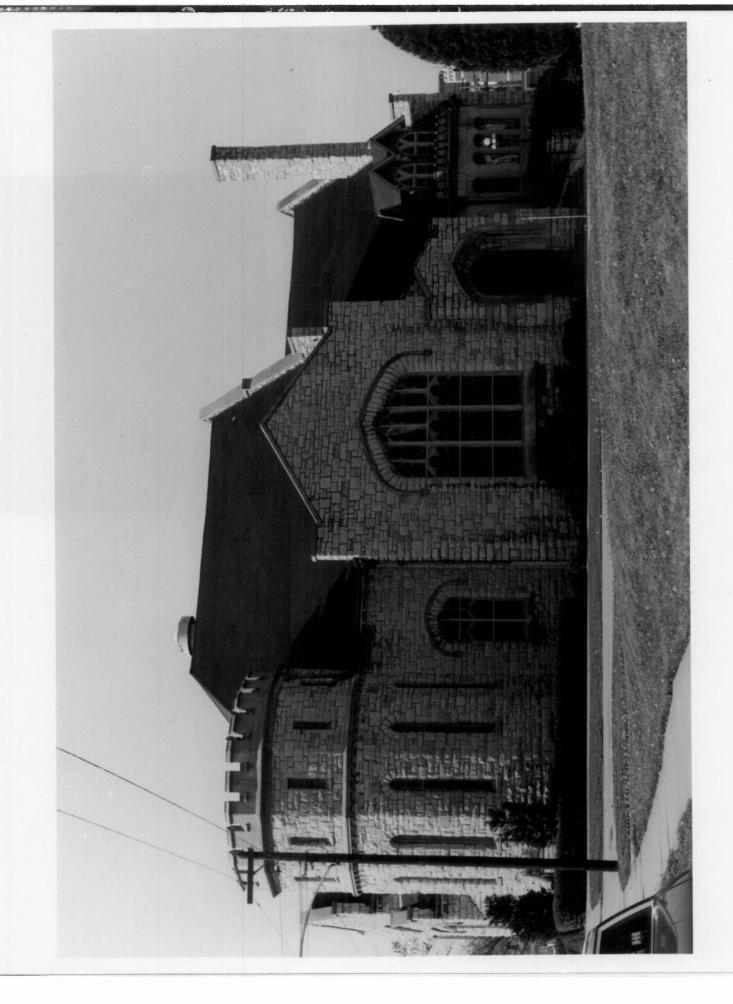
Westminster Congregational #1 Church Kansas City, Missouri photographer: Sherry Piland April, 1979

Exterior of north facade of church. View looking south.

The north facade, facing Thirty-sixth Street is the main facade. Located on the extreme east end of this facade is a two story, polygonal stone tower with a stone battlement. The tower contains slender louvered windows in rectangular frames on the second story and slender windows in rounded arches on the first story. Directly to the west of the tower is a stained glass window with stone tracery in a Gothic arch. Above the window is a stone hood mold. Next to the window and located in the middle of the facade is a large projection featuring a large stained glass window with stone tracery within a Gothic frame. A stone hood mold is also located above the window. The roof line of the projection is pointed with stone coping. The main entrance, located to the west of the projection is recessed within a modified cloister composed of paired columns with early English capitals. A secondary entrance is located to the west of the main entrance. A castellated semi-hexagonal stone bay is located on the west end of the north facade. The bay contains a painted three dimensional stained glass window. Directly above the bay is a pair of dormers with a pair of Gothic windows.

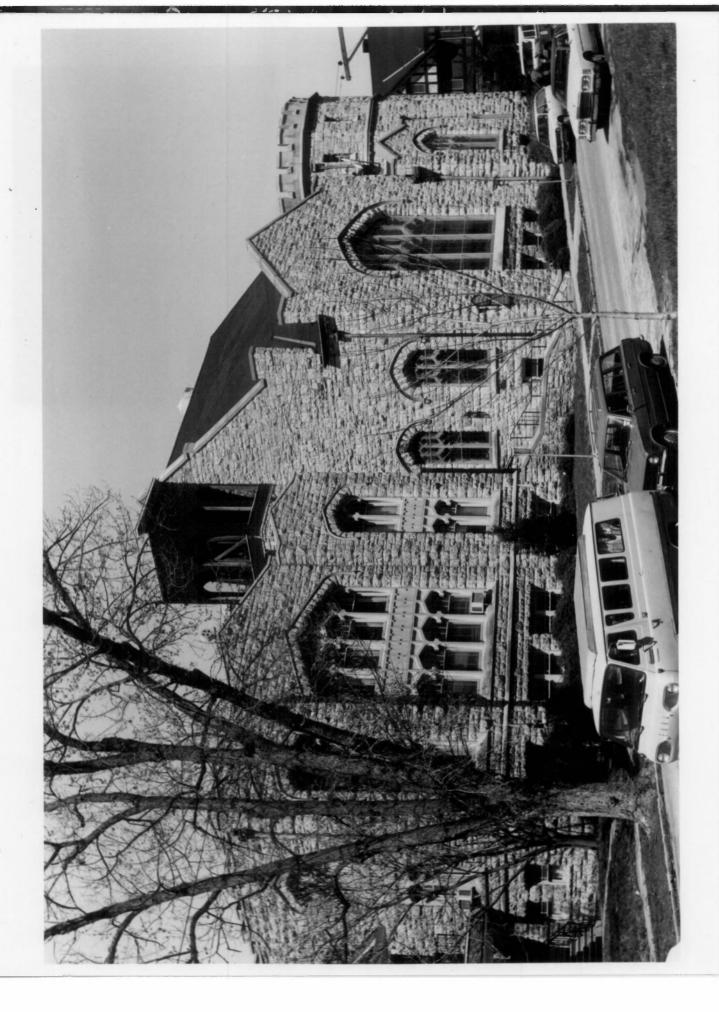
Westminster Congregational Church Kansas City, Missouri #2 photographer: Sherry Piland April, 1979

Kansas City Landmarks Commission City Hall - 26th Floor, East 414 E. 12th Street Kansas City, Missouri 64106 Exterior - East facade of church View looking northwest.

The east facade contains the tower at the northeast corner. To the south of it, is a small projection with a pointed roof line with a stained glass window with stone tracery in a gothic frame. Above it is a hood mold. To the south of this projection is another projection set back from the smaller projection. It too has a stained glass window with stone tracery within a gothic frame with a hood mold. One-over-one double hung sash windows in rectangular frames are located on the ground floor of the projections and tower. To the south of the recessed projection is an entrance set back and approached by a series of stone stairs. A door with fixed stained glass transoms is framed in a gothic arch. Above the entrance is a bell tower. The bell tower and entrance visually separate the 1904 section from the 1912 section. The 1912 section is three bays wide. A central bay contains a group of four Gothic windows on both the first and second floor within a Gothic frame and hood mold above. A projecting bay with paired Gothic windows on the first and second floor is located on either side of the central bay. The roof line of each bay is pointed with stone coping. A stone cross within a circle is located on the top of the central bay. The ground level of the central and northernmost bay contains paired hung sash windows in rectangular frames. A double wooden and glass door is located on the ground level of the southernmost bay. A stone course runs between the ground floor and the first story of the entire 1912 section.

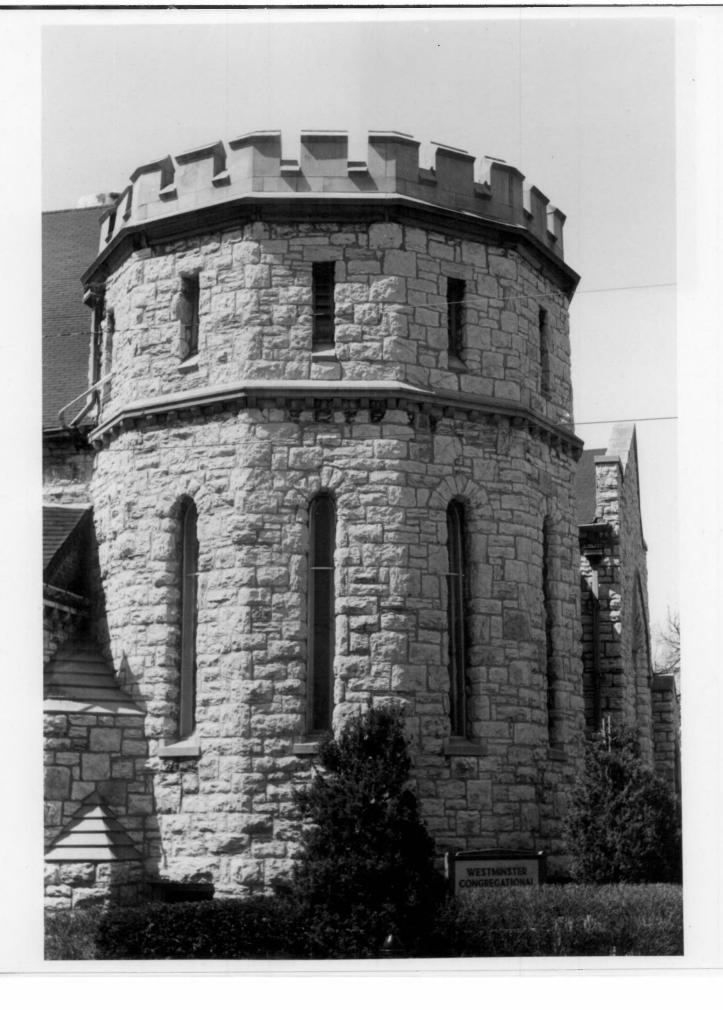
Westminster Congregational Church Kansas City, Missouri #3 photographer: Sherry Piland April, 1979

Exterior - tower located on the northeast corner of the church. View looking southwest.

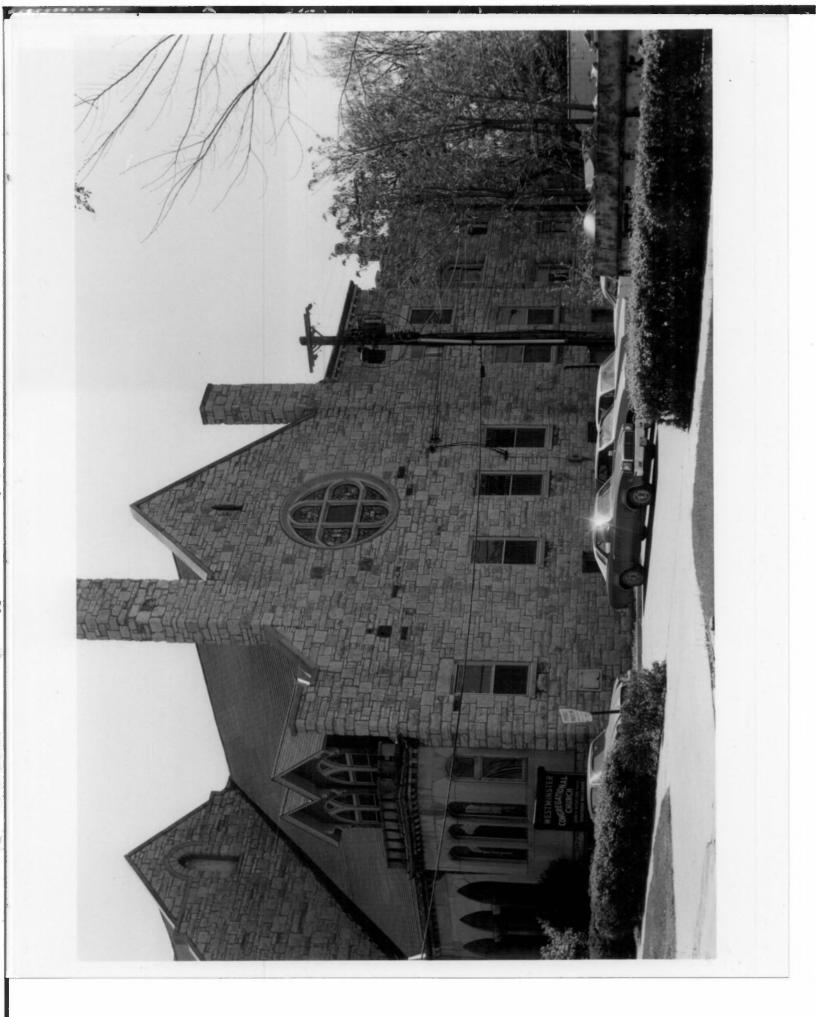
Exterior - West facade of the church. View looking southeast.

On the north end of the first floor of the 1904 structure are one-over-one double hung sash stained glass windows in rectangular frames. Above them is a round stained

glass window centrally positioned. The 1912 addition consists of sash windows in rectangular frames on the first and second stories and in Gothic arches on the third story. The roof line along this section is castellated. At the south end of the facade are wooden doors on each story connected by a fire escape.

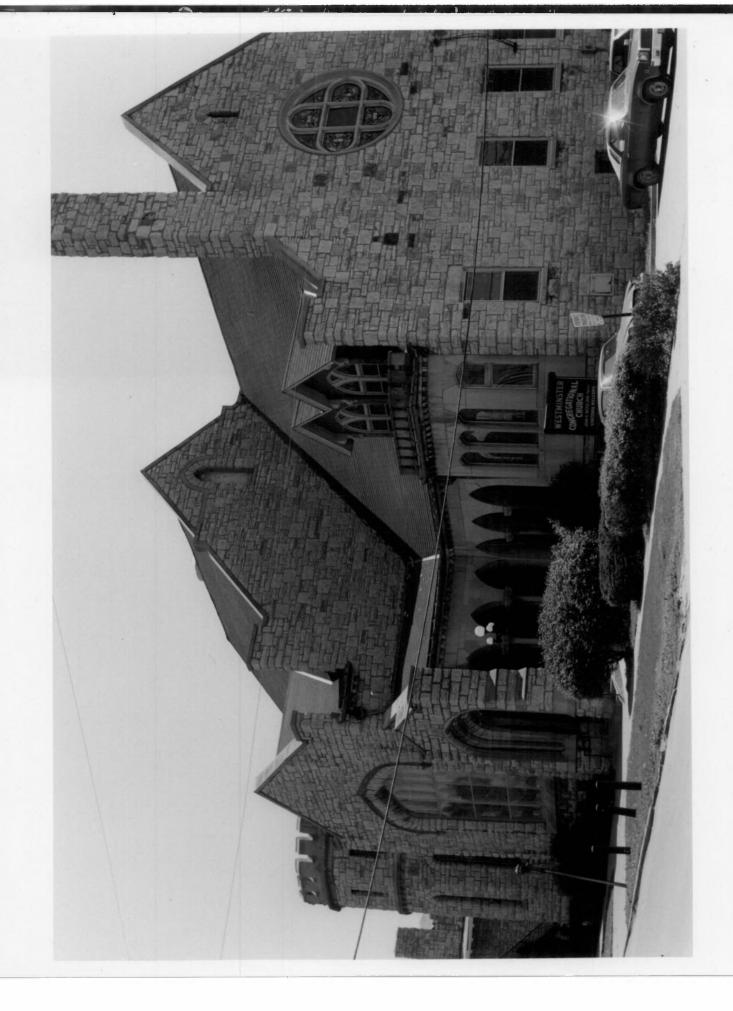
Exterior - Partial north and west facades. View looking southeast.

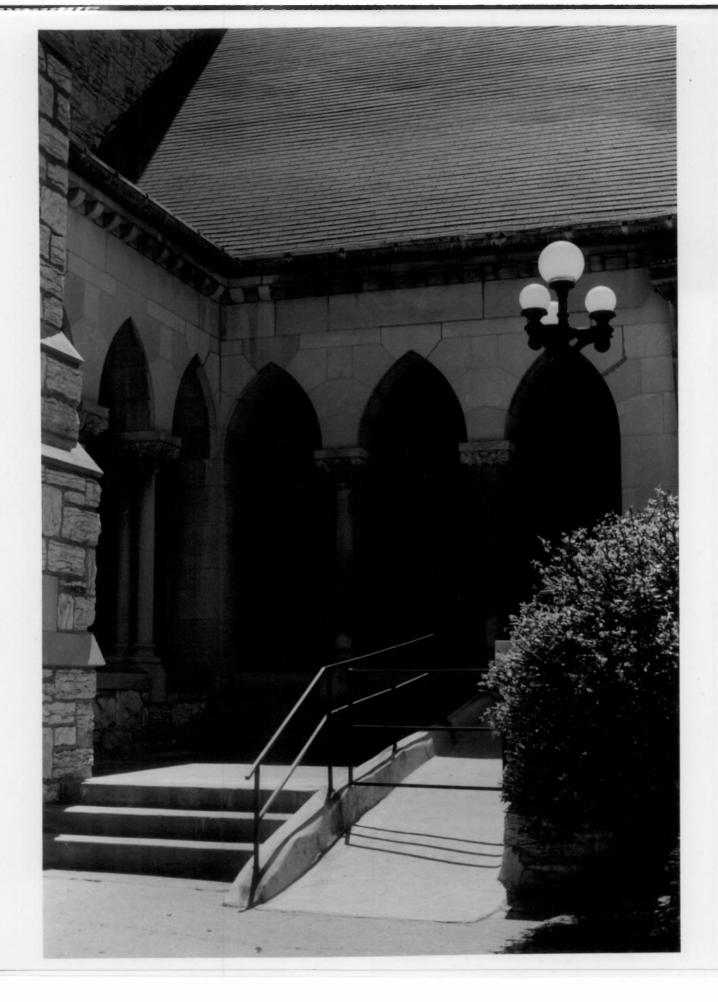
Westminster Congregational Church Kansas City, Missouri #6 photographer: Sherry Piland April, 1979

Exterior - Detail of modified cloister on north facade. View looking south.

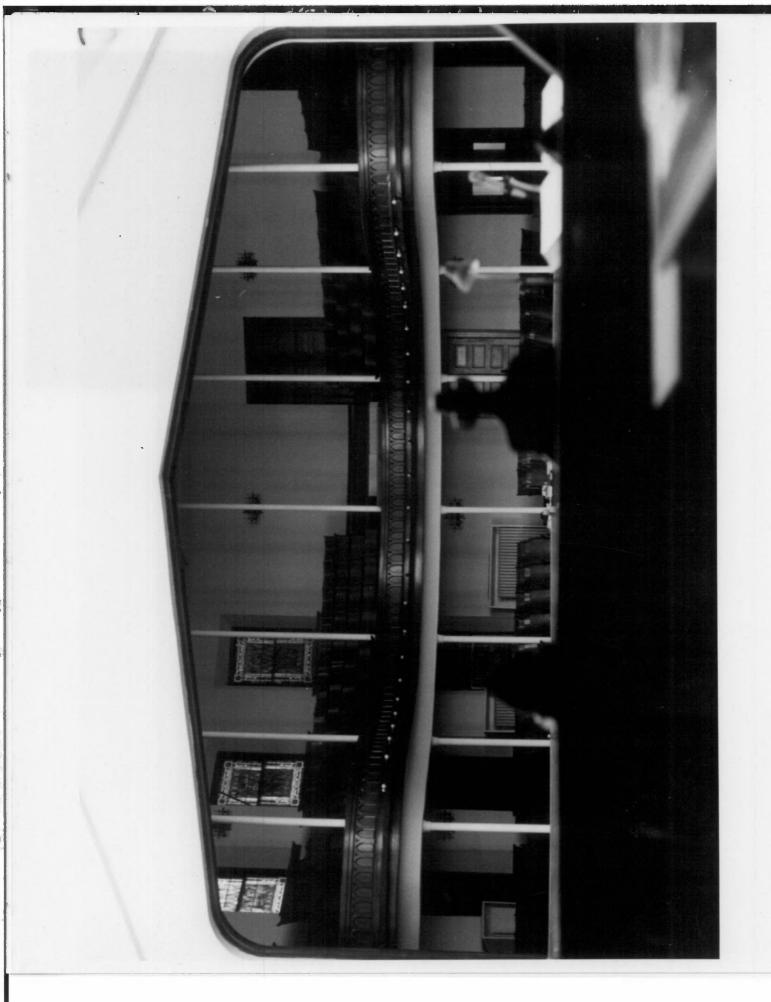
Interior - Horseshoe gallery and first floor located to the rear of the main sanctuary. View looking south.

Behind the main sanctuary, located in the southwest corner of the church is a horseshoe shaped area with ground floor and gallery, that can be closed off from the main sanctuary by a partition that drops from the ceiling. This horseshoe area has a small stained glass interior dome in the ceiling. The back wall of the horseshoe area in both the gallery and ground floor area contain one-over-one double hung sash stained glass windows in rectangular frames that open into the Sunday School area. A Gothic wooden arcaded balustrade runs along the gallery level.

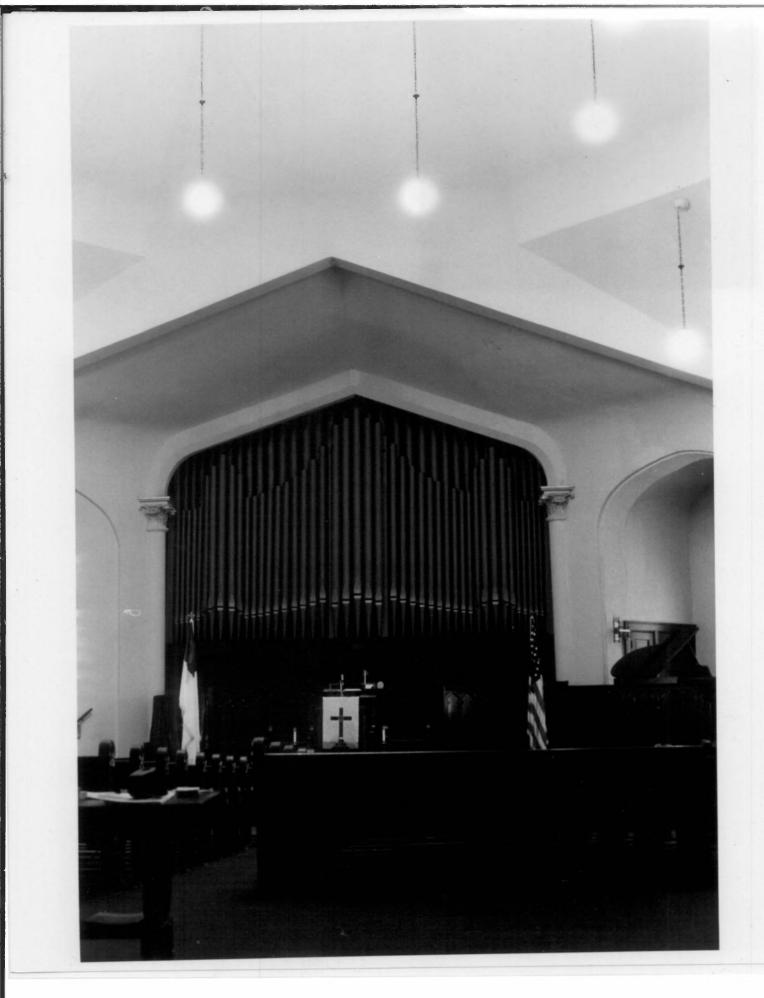
Westminster Congregational Church Kansas City, Missouri #8 photographer: Sherry Piland April, 1979

Interior - Main sanctuary of the church, showing altar platform and organ pipes. View looking northwest.

The interior of the church consists of an amphitheater shaped sanctuary. The seats are located in a circular form with the floor sloping downward to the pulpit platform. There are four side aisles with a partial central aisle. The pulpit platform, consisting of an altar, choir stall, and a pipe organ is located in the northeast corner of the church. There is a large stained glass Gothic window and a smaller one on the west facade; while a large stained glass window is located on the north facade.

"In its most common form the Akron Plan included a pulpit platform wedged into a corner of the building." The pulpit platform at Westminster is located at the northeast corner of the building and contains the pulpit, pulpit chairs, choir directly behind the chairs and the organ pipes behind the choir.

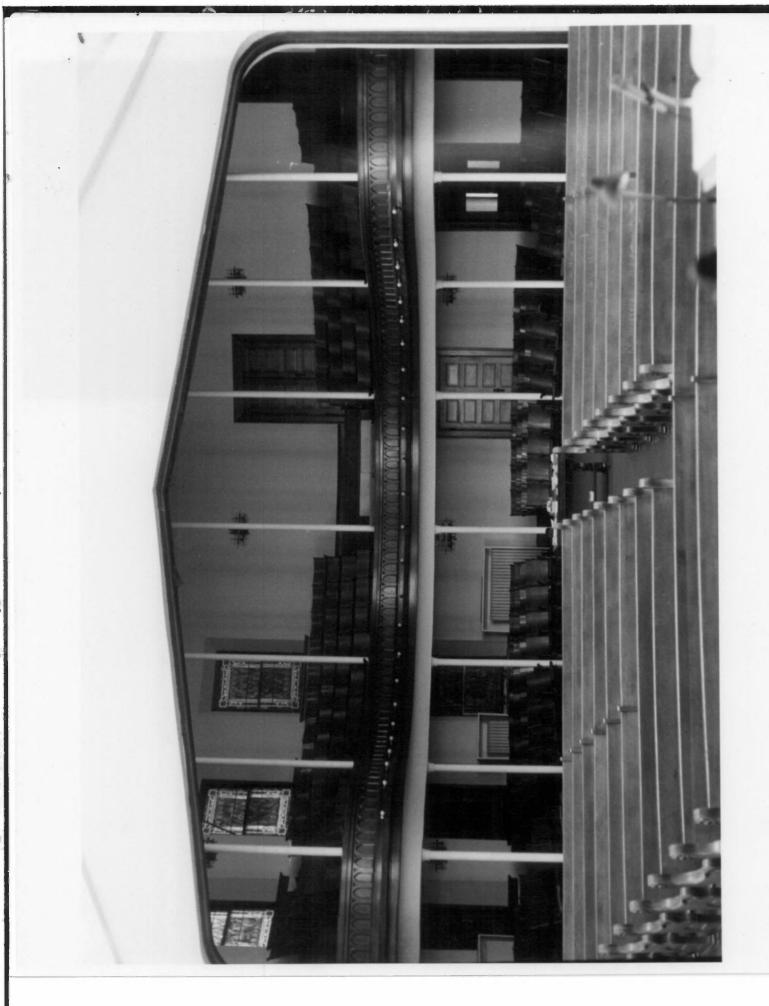
Interior - Horseshoe gallery and balcony located in rear of main sanctuary. View looking south.

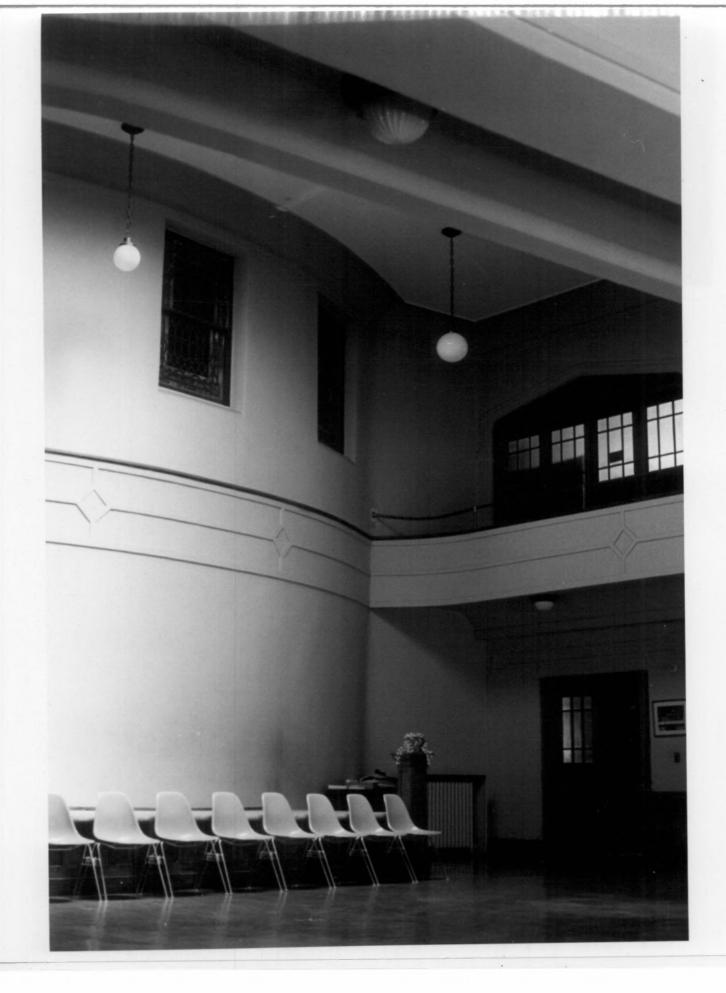
Westminster Congregational Church Kansas City, Missouri #10 photographer: Sherry Piland April, 1979

Interior - 1912 Addition showing detail of first and second floor of Sunday School rooms. View looking northeast.

Directly behind the horseshoe gallery, located in the 1912 addition are twenty-five rooms on both the ground floor and balcony levels. These compartments run around three sides of the large open space and can be closed completely by glass and wooden accordian type doors. They were designed especially for Sunday School use. The rooms on the balcony level are framed with Gothic arches while on the ground floor they are within rectangular frames. In the center of the ceiling is an interior stained glass dome.

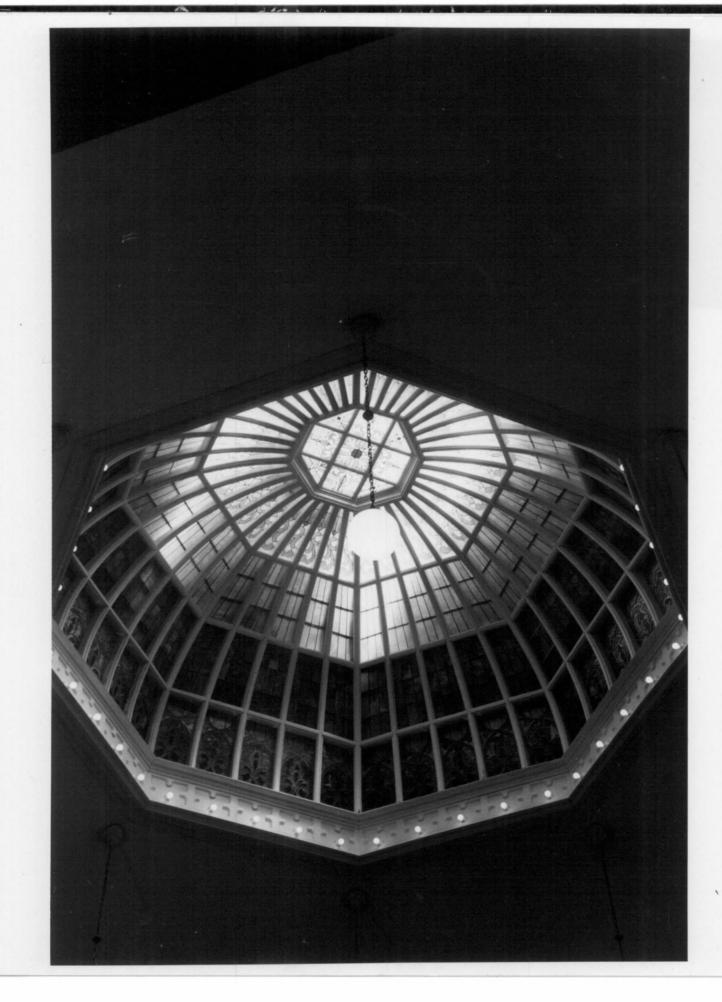
Westminster Congregational Church Kansas City, Missouri #11 photographer: Sherry Piland April, 1979

Interior - Stained glass dome located in main sanctuary.

The ceiling of the church is polygonal in shape and is supported by ribs rising from four Corinthian pilasters. An interior stained glass dome is located in the middle of the ceiling. The walls of the church were smooth plaster originally, but have been texturized.

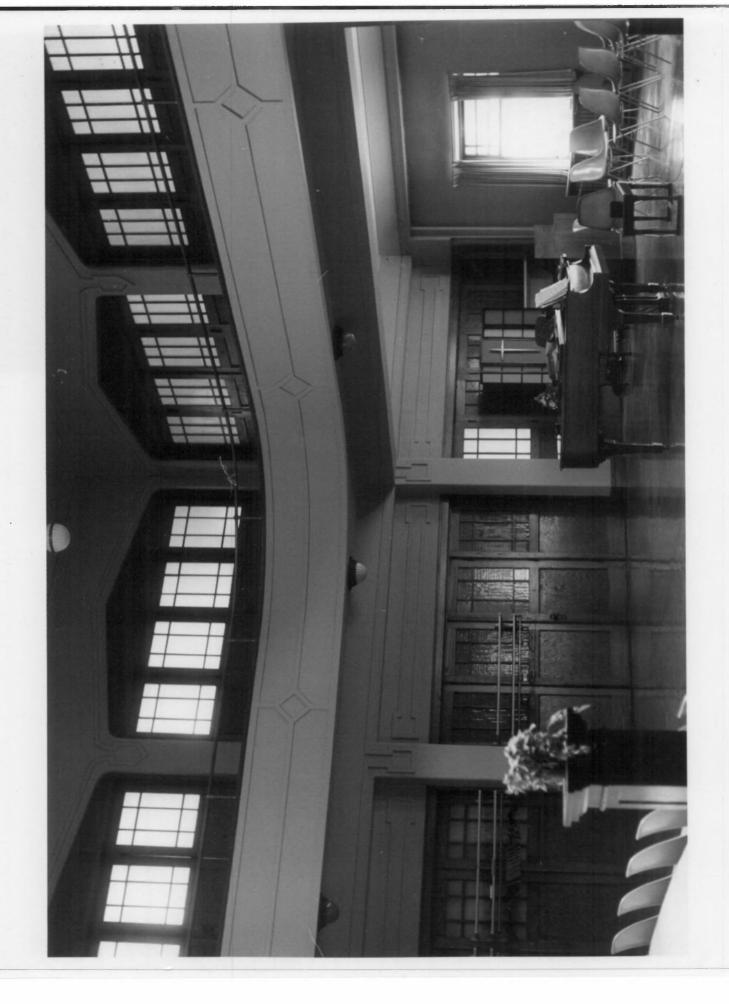
Westminster Congregational Church Kansas City, Missouri #12 photographer: Sherry Piland April, 1979

Interior - 1912 Addition, first floor and balcony showing accordian door partitions for Sunday School. View looking southeast.

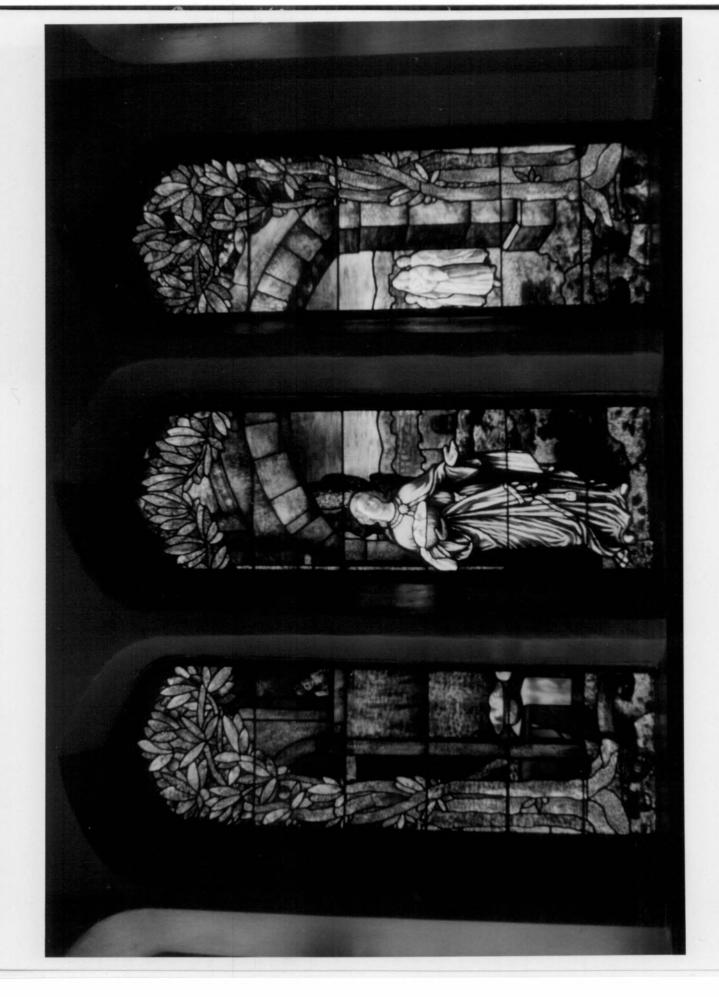
Westminster Congregational Church Kansas City, Missouri #13 photographer: Sherry Piland April, 1979 Kansas City Landmarks Commission City Hall - 26th Floor, East 414 East 12th Street Kansas City, Missouri 64106

Interior - Painted three-dimensional glass window in Women's Parlor. View looking north.

Two rooms are located at the west end of the sanctuary, a small parlor originally used as a women's parlor and a room directly behind it once used for infant classes. Surrounding the entire women's parlor is red oak wainscotting with a Gothic arch design. A fireplace is located on the west wall of each of the two rooms. Directly above these rooms is a large room that was used at one time as the pastor's study. It is presently not being used.
